Superior Coal Mines,
Wooden Structure
Sections 28, 29, T21N, R102W
Horse Thief Canyon
Old Superior Mines and Townsite
about 1/4 mile north of South Superior
Sweetwater County *South Superior vicinity*
Wyoming

HAER No. WY-51-C

Superior Coal Mines, Wood Structure
HAER No. WY-51-C

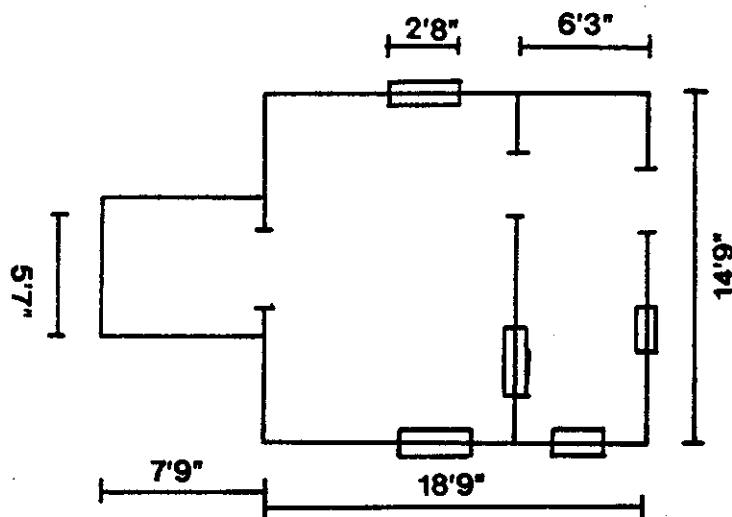
Wooden Structure,
Superior Coal Mines
HAER No. WY-51-C
(Page 3)

The wood structure (Structure C) is rectangular in shape with the long axis oriented from east to west. The overall dimensions of the structure are 26 feet 8 inches east to west by 14 feet 9 inches north to south. The structure has a flat roof which slopes downward to the west. The roof is covered with green asphalt tar paper. The foundation of the building consists of 8 inch x 8 inch milled lumber beams resting on uncut dry laid sandstone slabs. The walls consist of milled lumber planks secured to a frame of 2 inch x 4 inch boards with metal nails.

The interior of Structure C is divided into three rooms, an eastern room or porch, a large central room, and a small west room excavated back into the hillside. The east room is rectangular with the long axis running north to south. Its overall dimensions are 14 feet 3 inches by 6 feet 0 inches. The height from the floor to the roof is 6 feet 9 inches. The floor of the room consists of milled lumber boards. The walls consist of the wood frame and exterior wood planking of which much of the eastern wall has been removed. The western wall serves to separate the east room from the center room. This dividing wall has two openings. A doorway which provides access from the east room to the center room is located near the north edge of the wall. The door has been removed. A second opening is located near the south edge of the dividing wall. The window has had its glass and frames removed.

The center room is rectangular in shape with the axis running from north to south. The dimensions are 13 feet 10 inches by 11 feet 7 inches. The height of the room ranges from 8 feet 6 inches at its east end to 5 feet 7 inches at the west end. The floor consists of milled lumber boards. The walls consist of the wooden frame and exterior boards and the roof consists of the wooden 2 inch x 4 inch board rafters. The northwest corner of the structure contains a small fireplace. The fireplace consists of a stack of concrete blocks with a small hole in the south side of the lowest two blocks. A vertical shaft runs up through the center of the stack of blocks which extends through the roof forming a chimney. The entire stack of cement blocks is supported by four 2 inch x 2 inch wooden legs which hold the blocks 4 feet 5 inches off the floor.
